FÓRUM LATINO-AMERICANO DE SMART GRID

**ASSETS MANAGEMENT AND MONITORING
FOR IMPROVING RELIABILITY AND
OPERATIONAL EFFICIENCY**

Megger Grid Analytics

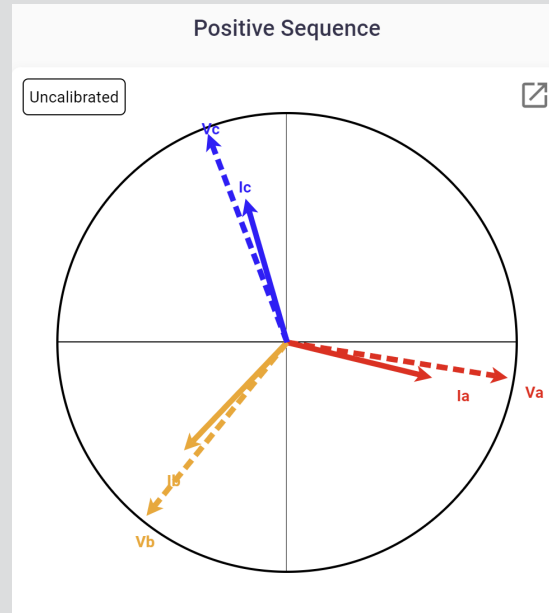
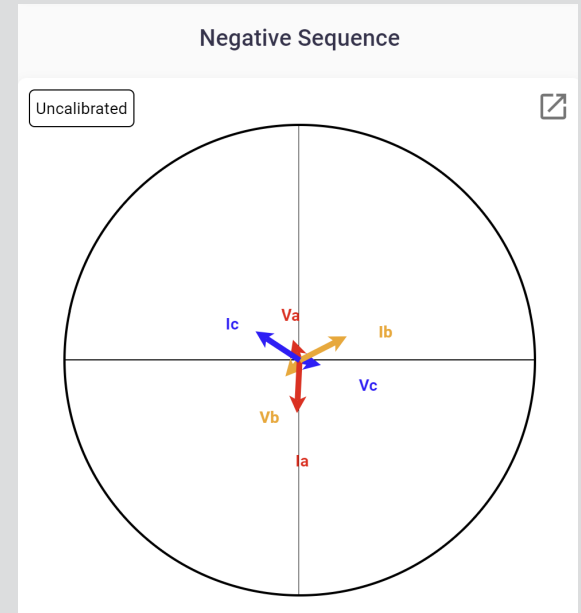
Symmetrical Components

Value	Angle		Value	Angle
V	12.692 kV	-8.0°	V	0.885 kV	107.9°
I	41.58 A	-12.2°	I	2.64 A	-93.4°
	Value	PF		Value	PF
I/V Angle	-4.2°	0.99727	I/V Angle	-201.2°	-0.93210

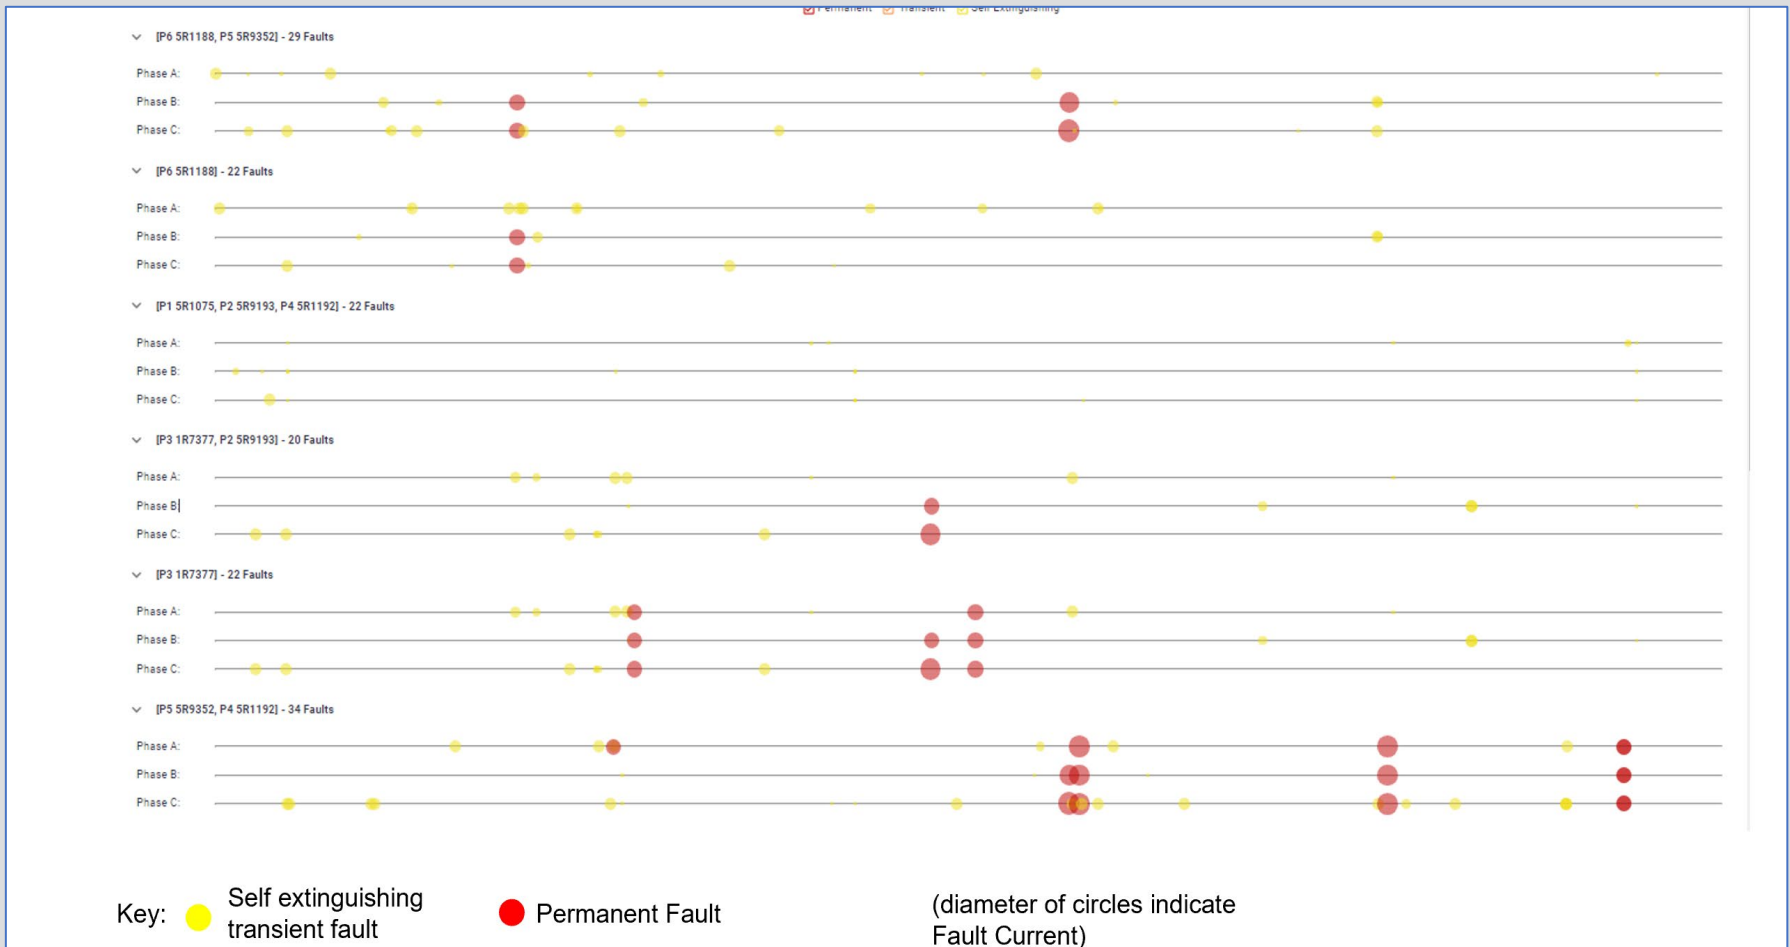
A year of Fault data can identify lines & phases with weak spots

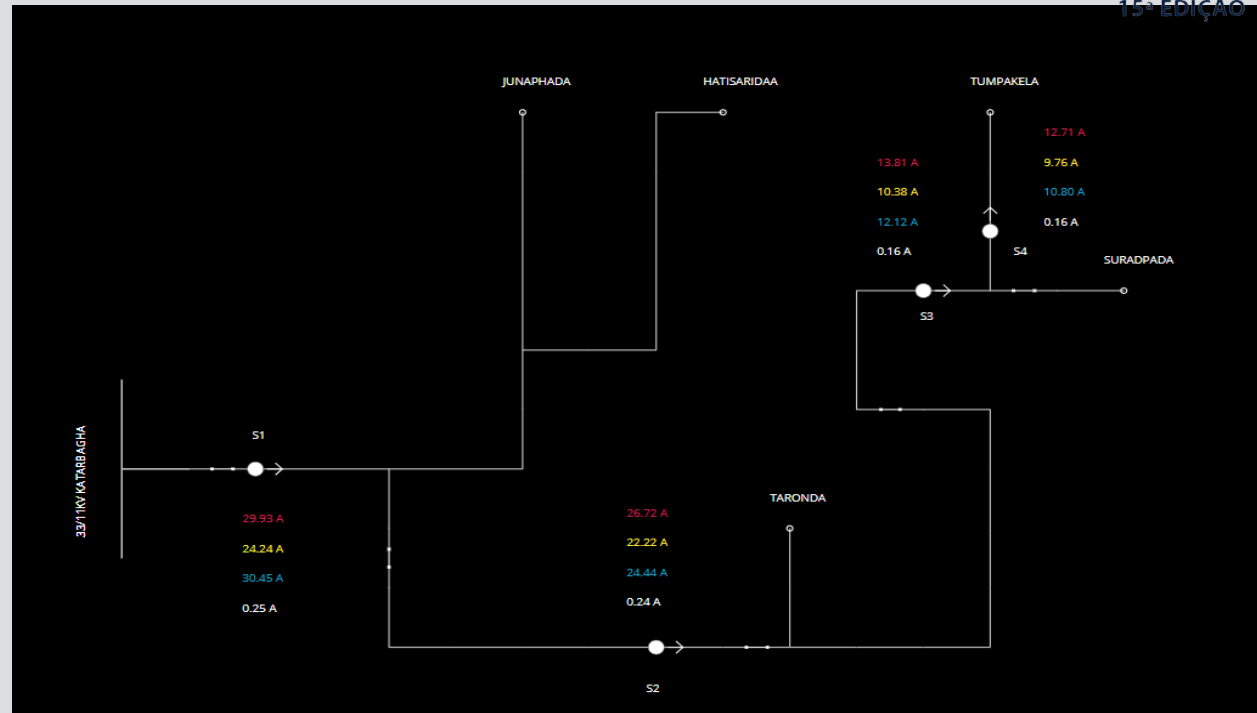
Katarbagha to Tamperkela 11 KV line

Line Diagram was designed in Metryview Software as per the sensor locations

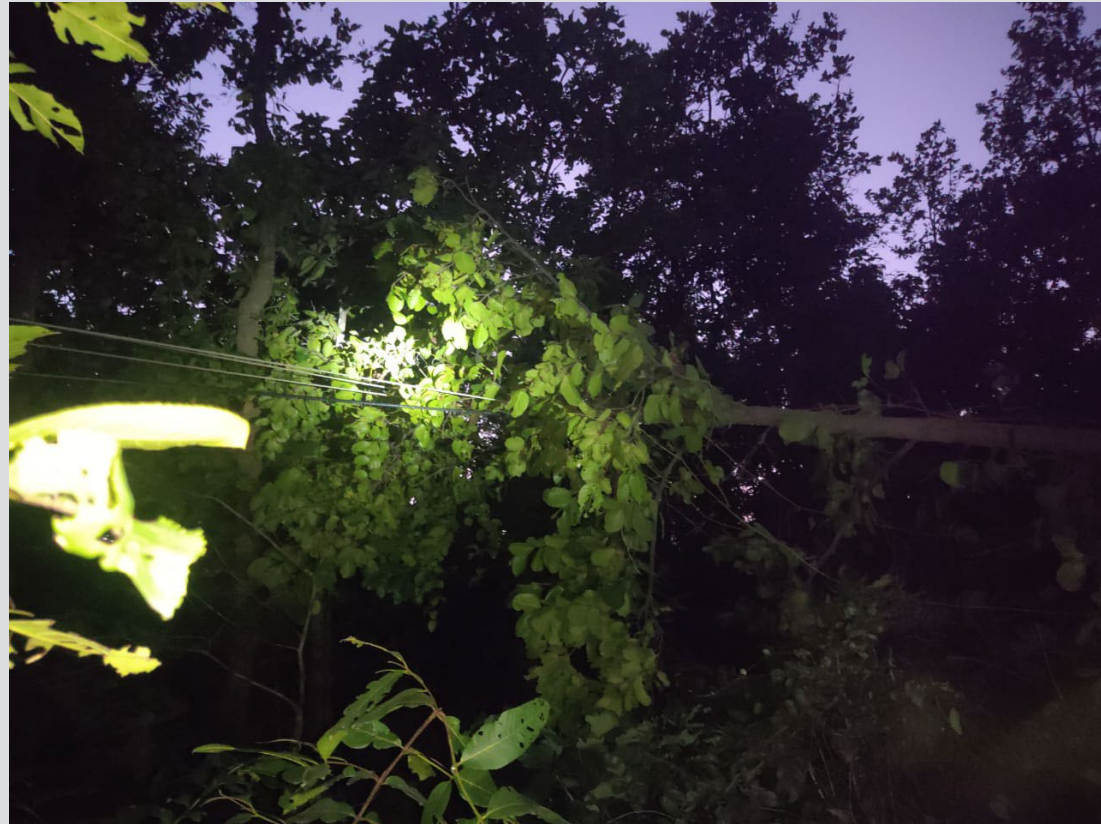
Root Cause of the Permanent Fault

- Tree branch was hanging on 11 kV line
- Local people were cutting the trees & During cutting the Branch was fallen on an 11 kV line Permanent Fault Occurred.

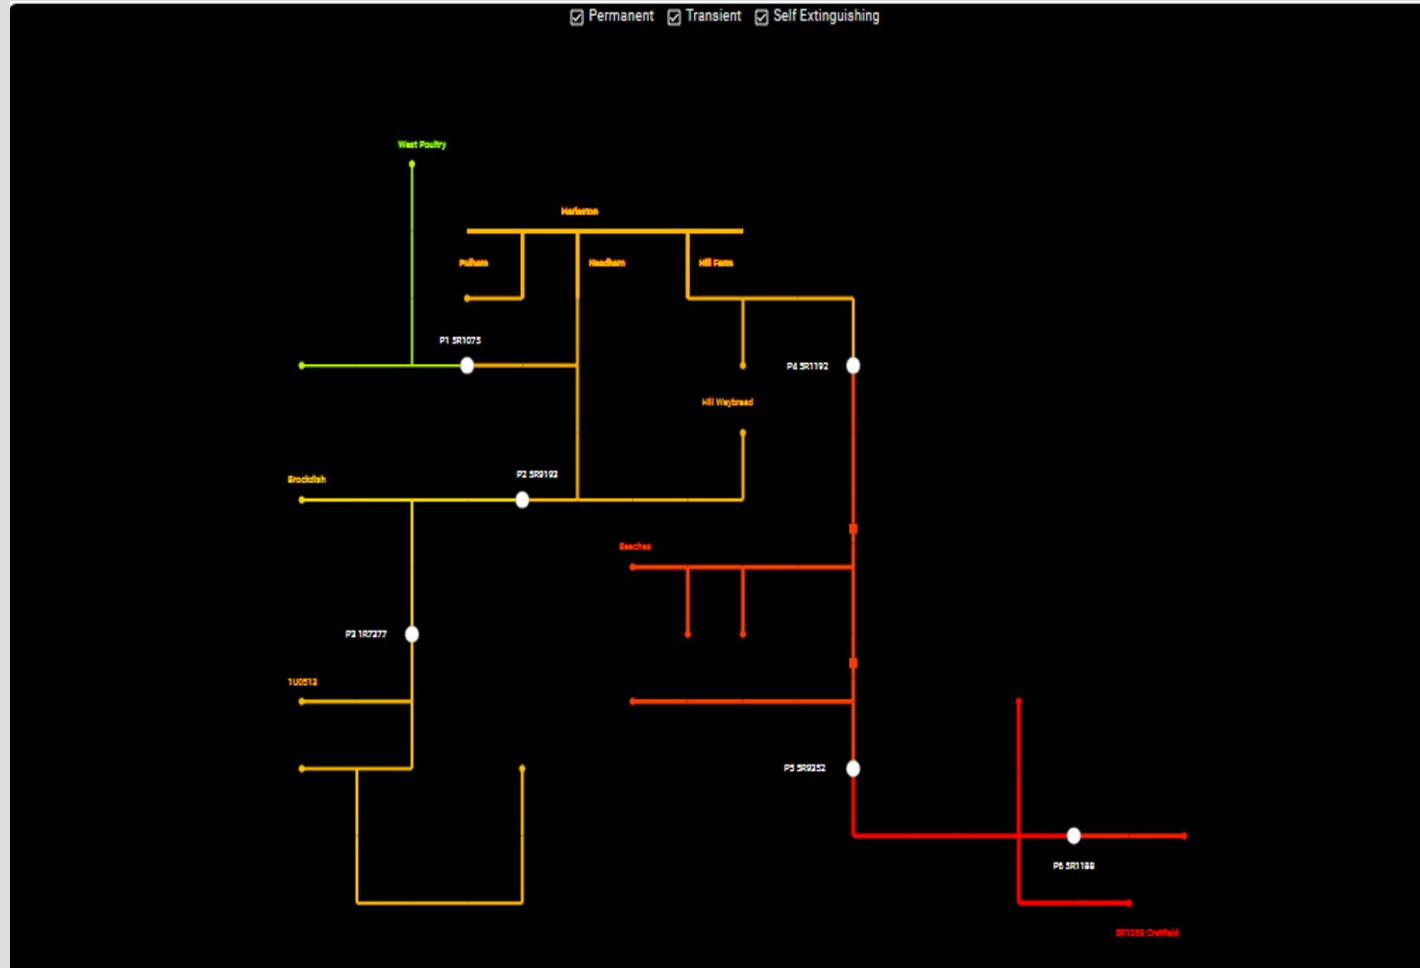
Heat Maps can be used to identify Weak-Spots in Networks

- Smart Grid Sensors can identify Weak-Spots in Networks
- Fault data for typically period of a year can be used to create 'Heat Maps'
- Pareto principles can be applied to improve reliability
- Vegetation issues, Insulation problems, Extreme weather weak-points)
